**National Highway  
Traffic Safety  
Administration**

Case Vehicle (A): 1999 Chevrolet  
Type: Venture 4 x 2, 4-door APV  
Driver: 18-year-old male  
CDC: 12-FREE-5, 09-LZAW-4

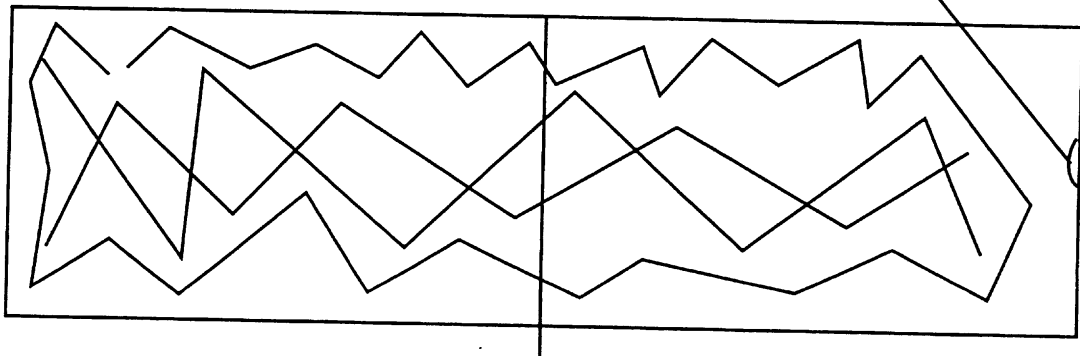
Small amount of bond separation  
less than 1% of total

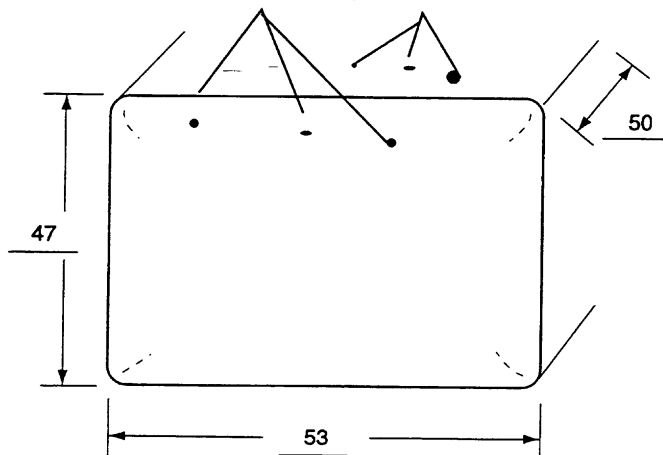
Passenger Airbag

Multiple small holes in airbag fabric from broken windshield glass
